## Replacing Forward Heads Pipes in a Moody 376.

### Voyager IV of Emsworth

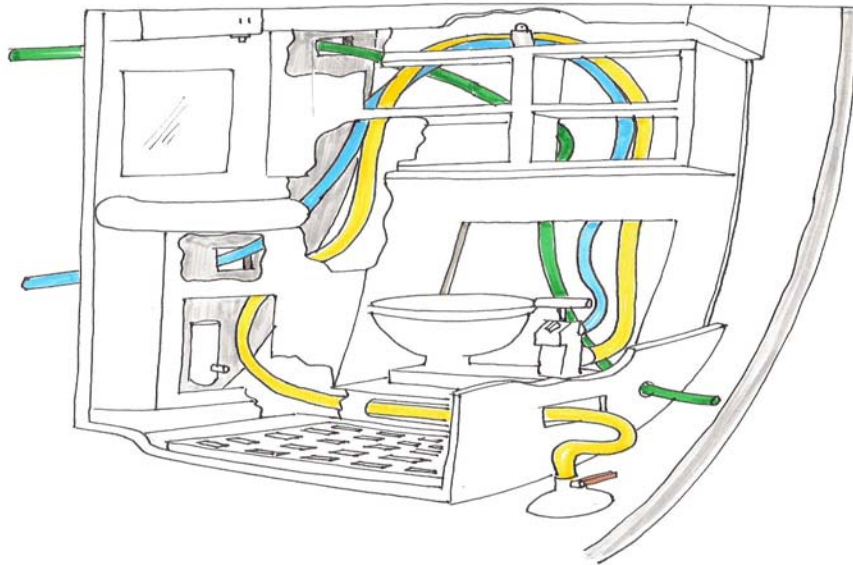
Schematic of arrangement. Shower discharge pipe not shown  
(Courtesy of William Parker watchleader)

The heads piping passes into the bulkhead behind the WC and then reappears either, in the case of the inlet pipe, in the starboard forward under bunk locker, or in the case of the outlet pipe, in the starboard side under seat locker in the saloon.

The inlet pipe passes through the forward bulkhead in the basin cupboard just under and behind the basin itself. This brings it easily into the forward under bunk locker at top of that locker. The seacock itself is approximately one metre forward of the bulkhead just to starboard of the central fore and aft line. There is another seacock in this locker which exits on the waterline, this is the shower drain seacock and does not concern us here.

The outlet pipe descends to the bottom of the basin locker, turns sharply aft and passes under the WC pedestal and through the aft bulk head of the heads and into the starboard under seat locker at the forward end of the saloon. The seacock lies in the middle of this locker. There is a schematic of all this at the end of the article.

The attached drawing shows the basic layout of all the pipes with exception of the shower pipe and the breather pipe.

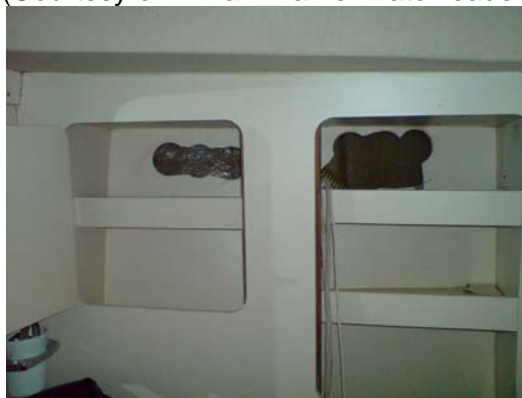
Holes cut in Upper heads lockers. (CUT THE AFT ONE FIRST)

We cut a hole in the forward upper locker in the heads above the shelf with a tank cutter. This resulted in us making a hole with the drill in the INLET pipe, which we had not intended to replace! . However this revealed the two pipes, which were suspended rather high up behind the locker back by a plastic cable tie of impressive proportions. Unable to get at it from the forward locker hole we then cut into the aft heads locker, again above the top shelf with a tank cutter and enlarged the hole with further tank cutter cuts and a small hack saw. (See Picture)

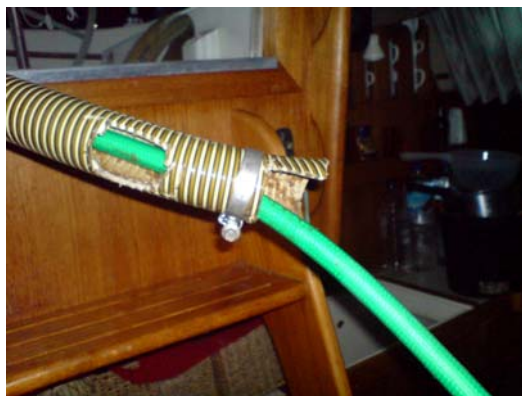
This shows the old outlet pipe on its way to the rubbish bins. It shows the use of the garden hose.

possibly jamming, we decided to pass a stiff garden hose through the whole of the 1 1/2 inch discharge pipe. We cut the discharge pipe away from the seacock and inserted the hose from that end. This proved fairly easy since there was no scale at that end. The garden hose got stuck at approximately the apex of the pipe behind the locker at the top. This was because the scale was very thick around the pipe walls at that point. Deciding that we could probably feed the hose onwards to the bottom behind the bulkhead on its own we then cut the discharge pipe away from around the hose and then the hose and the cut away pipe were drawn to the bottom together. We then cut the large cable tie with a hacksaw blade using heavy duty rubber gloves with which to grip it. We suspended the pipe inside the locker with some line.

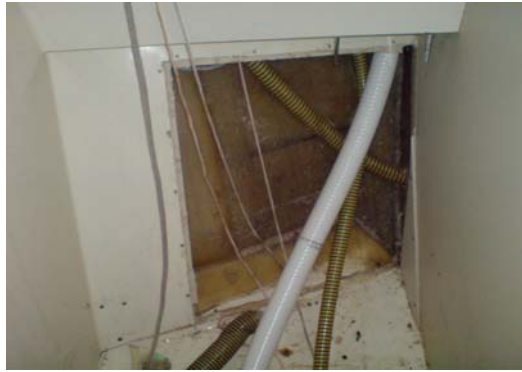
Shows panel removed from behind the WC and the new white pipe being pushed up behind the paneling. Green pipe hanging down is the old inlet pipe. Diagonally from right to left is the fresh water tank breather pipe. At the bottom is a piece of the old discharge pipe we cut away

One point about another (yes, yet another pipe) which one sees passing up behind the heads paneling. This is a 3/4 inch pipe travelling diagonally from the saloon/heads bulkhead to the area near the apex. This is the freshwater breather pipe and exits into the anchor windlass well in the bow. We managed to avoid drilling through this one.

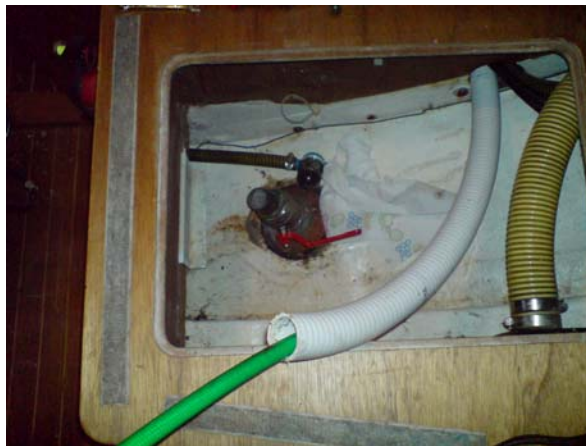
Shows garden hose pipe still protruding from the new pipe at the end of the job. In the background is the shower discharge filter. We had to cut the pipe to ease the passage of the 1½ in pipe through the hole. We re-fixed it afterwards. On the right is the fresh water filler pipe.

We then passed the new white odour free pipe over the far end of the garden hose, from the WC end and began feeding it up to meet the old pipe at the apex. With some juggling we got it past the apex and over the line mentioned above so that the new pipe and the old pipe met at the top. We then pushed the old pipe along the hose with the new one and with a lot of pulling and pushing the new pipe appeared in the locker. We then pulled the garden hose out of the new pipe (See picture) and the main job was done.

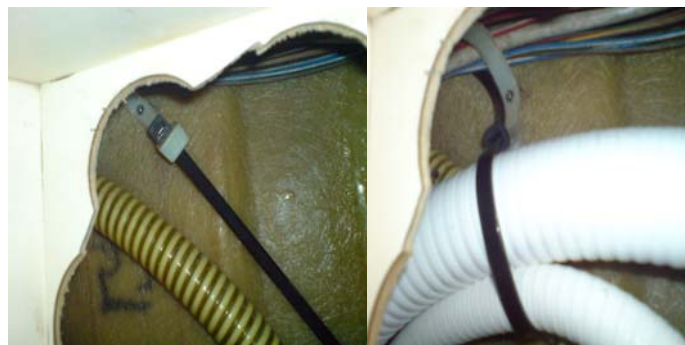
This shows the use of the “old” cable tie as a support for the new one.

We thought it important to suspend the pipes again at the apex and using the open end of the old rather large cable tie, which we had sawn through earlier, did this. We passed a smaller cable tie through the hole (see picture)

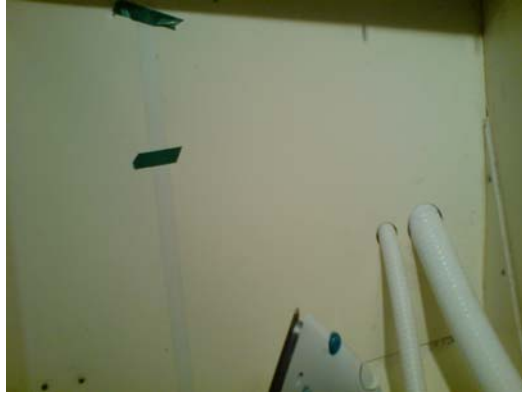
Difficult to see, but the iron on plastic tape normally used for end of kitchen shelving made of chipboard can be ironed on to conceal the screw holes of the panel. The cross tape is insulating tape used to hold the white tape on during the ironing process.

Basically after this it is all re assembly and making new backs for the heads lockers. We cleared out the heads pan and assembly with vast quantities of Harpic lime scale remover (no I don't work for them). We did buy a new pump unit from Jabsco which is an easy retrofit.
