## Moody 31 Mk II Cabin Windows – Eddie Cross ‘Trouvaille’

Trouvaille of Orwell is a fin keel 1986 Mk II Moody 31, the cabin windows, not only had a suspected leak on the rear starboard side, but created condensation which dripped onto the carpet in the rear cabin

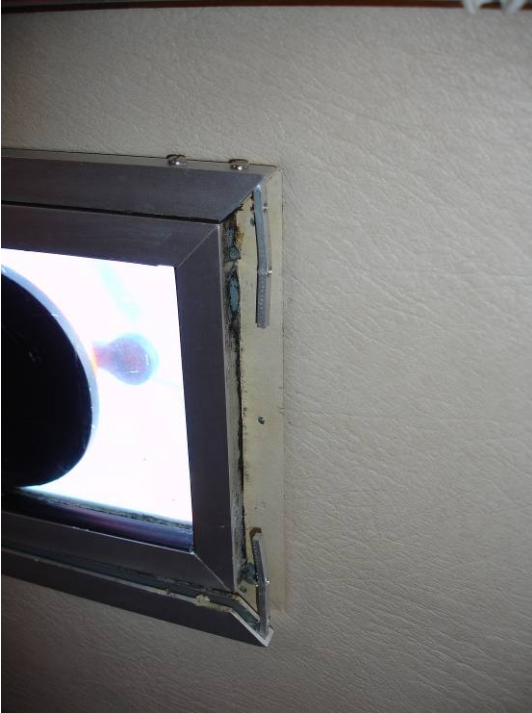
To remove the windows, firstly remove the screws from the outer frame, these go through the hull into the inner frame.

The issue with the inner frame is the stainless screws at the joints, these were corroded due to the mismatch of metals as the joining components were aluminium strips.

You don't have to remove them all to remove the frame

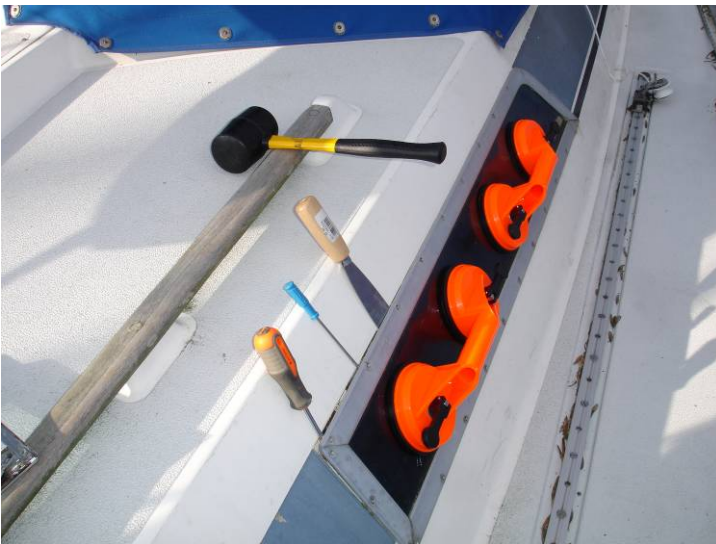
To remove the windows, from the inside cut around the window to break the seal of the old mastic, I actually used a 1½" wide scraper as the blade was stronger than a Stanley blade.

Once this was done I found that there was movement in the window frame. On the advice of Steve from Talking Plastics I invested in the glass lifters £5 each from ScrewFix. These were a big help then by pulling the window outwards and inserting the scraper blade followed by different size screwdrivers the windows were easily removed.

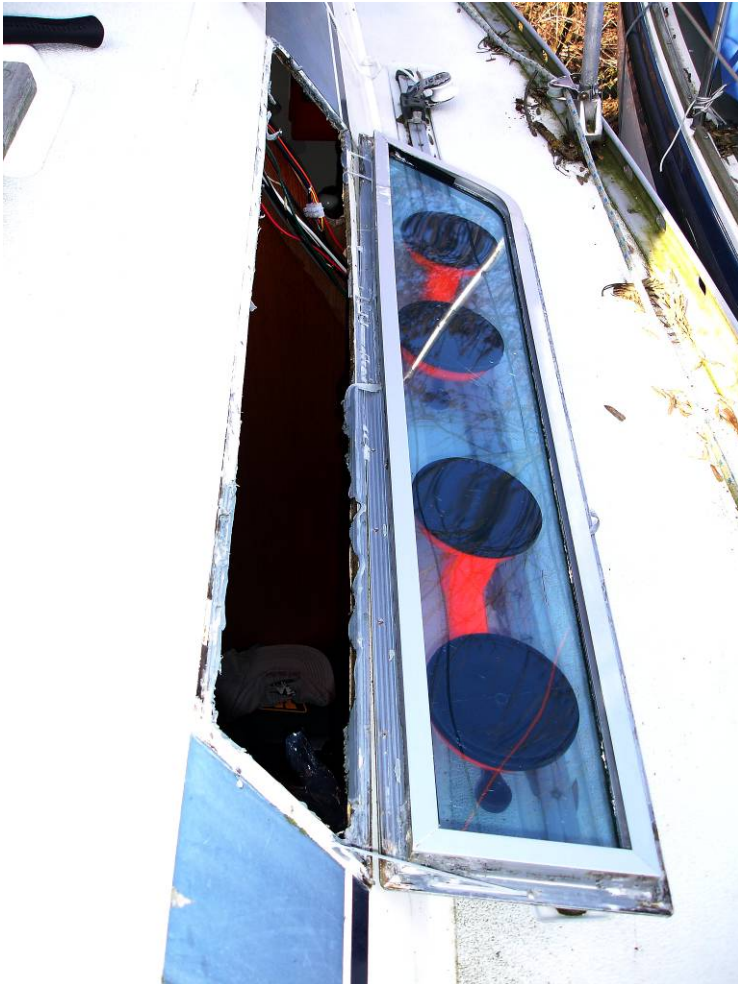
It was then apparent that there were leaks from the old frames where the mastic hadn't taken.

I would suggest that up to this point the above methods could be applied if the windows wanted re-sealing, I was pleasantly surprised on how easy they came out about 20 minutes per window.

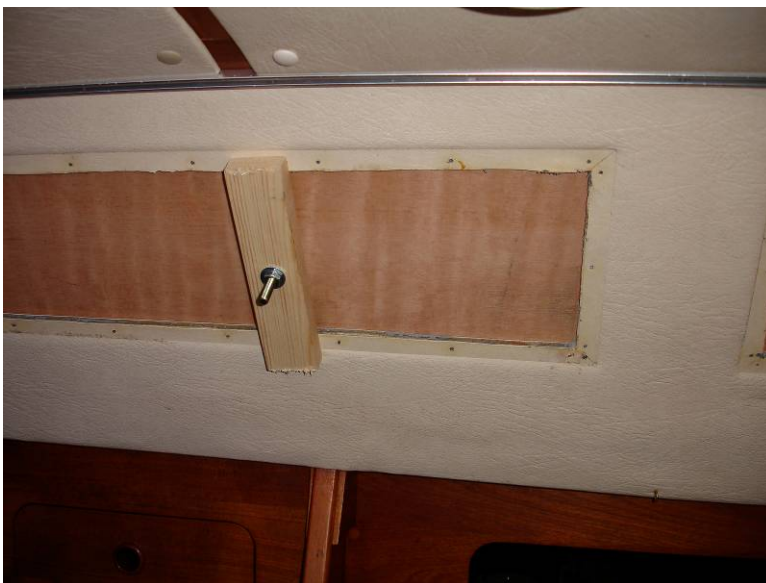
I then used ply, secured in place with 2 x 1 battens to replace the frames, I also used a bead of silicon applied from the inside to fill any gaps to make it weather proof.

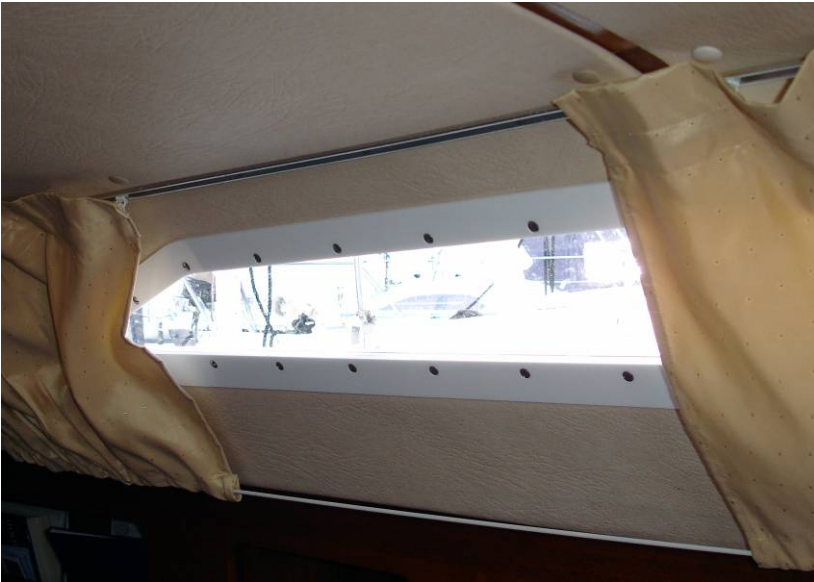
The Talking Plastics solution is an inner frame, secured to the outer frame from the inside by screws (that don't pass through the hull), that locate in the outer frame and are fixed with helicoid threads

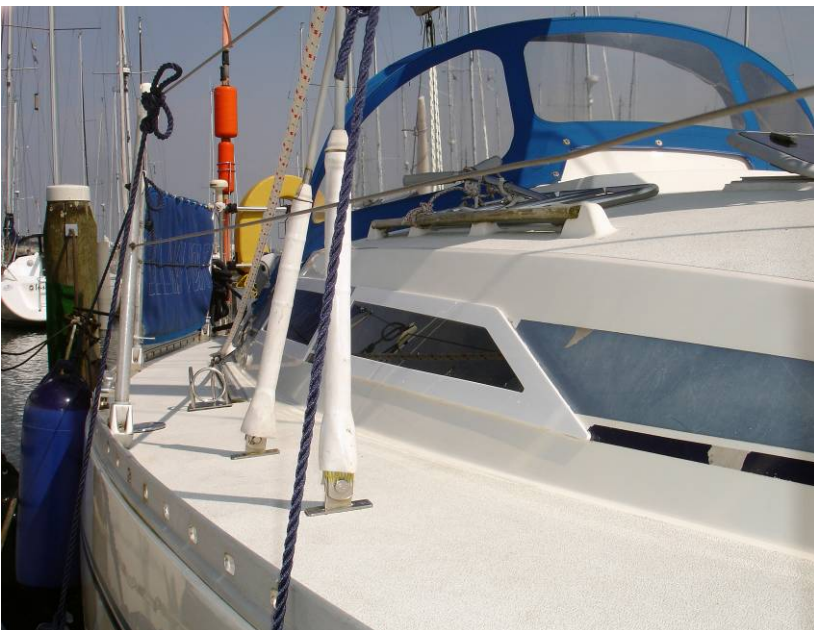
The outer frame was sealed with sufficient mastic to squeeze out all round. I allowed this to partially cure, and then it was easily removed with a Stanley blade.

Whilst it is true that the white of the plastic frame is a brighter white than the original hull pigment, it is not very noticeable as the decals distract the eye

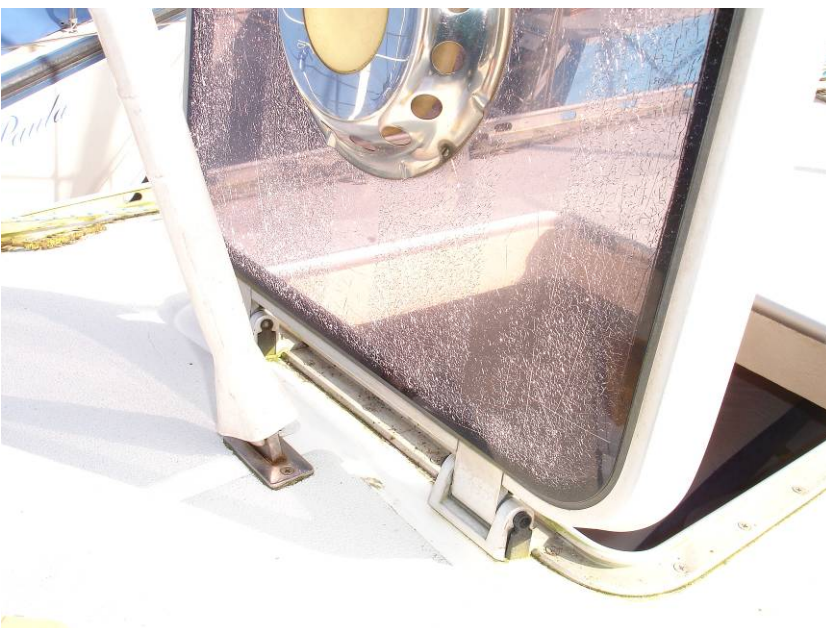
I also took the opportunity to renew the fore hatch, as I didn't fancy replacing the whole unit, as I had no idea how to tackle the stretched headlining.

The hatch was easily removed, by taking out the hinge pins, As this is a stop lock hinge, I renewed that mechanism at the same time the Lewmar instructions as easy to follow.

When the polycarbonate was replaced I did away with the vent, as we now use mosquito net covers
