Galley update on a 1979 M36

Doing the dishes

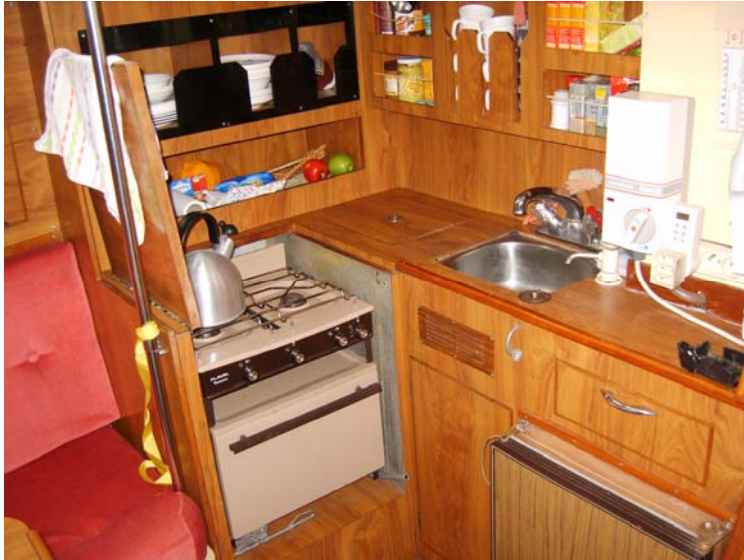
I've always resented doing the dishes on my Moody 36 Victor Too. Not just because there's no dishwasher, but the galley lay-out was a typical L-shape with the sink close to the bulkhead with the back of the outside bench protruding over it. It always gave me back pain because at 5ft9 my head was in the way, or perhaps it was the bulkhead.

So with the prospect of spending a year cruising, something had to be done about the lay-out of the galley and the positioning of the sink.

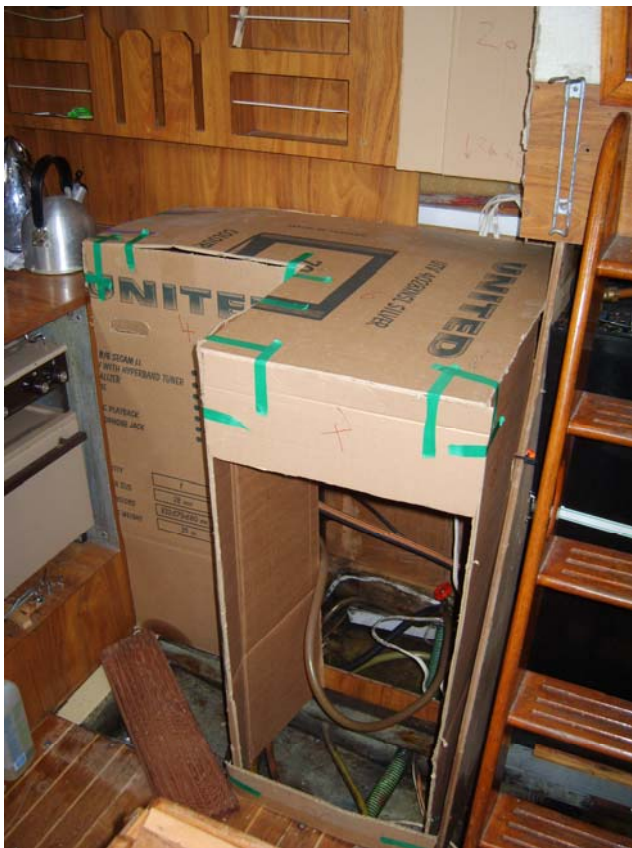
burner, so I left those alone. After ordering the necessary parts, the removal of the old worktop took some creative destruction.

I then built the basic structure in cardboard, to enable measurements being taken. Needless to say, the old tubing and electricity were replaced where necessary while everything was removed.

The worktop was elevated by 4 inches to make galley work easier for taller people. I moved the sink to the new part sticking out to shape the "U".

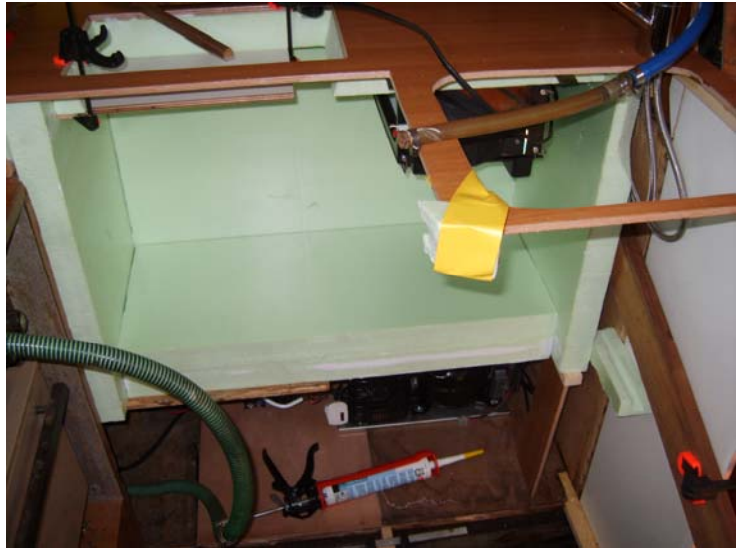
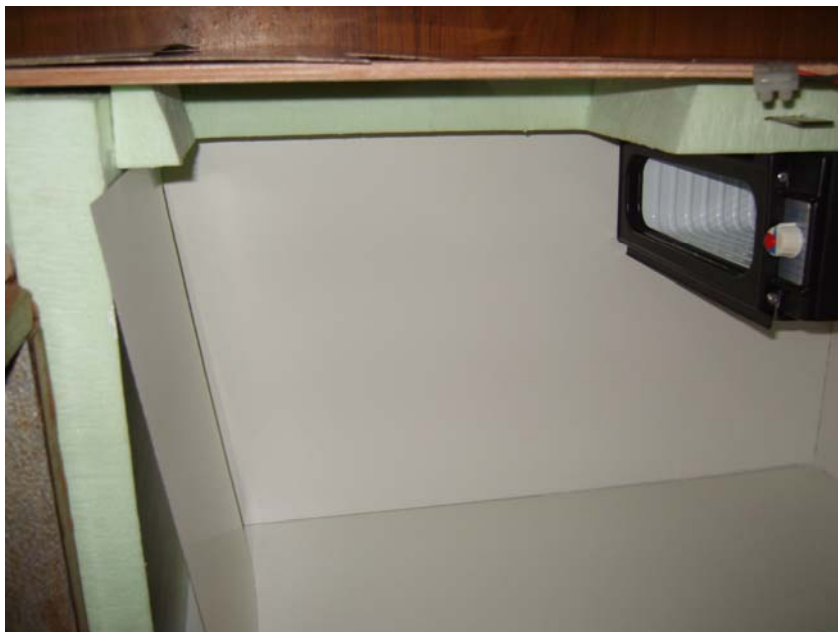
The sides of the fridge are covered in white wood veneer – leftover bits from the marine multiplex I ordered. Putting the fridge together needed some tight planning as once it's there, it will never come off without destroying it partly. I rehearsed this part two times to make sure everything fitted neatly. Actually gluing everything together proved easy after I had made up a list of which things to do in what order. The glue I used was PU-glue as well as PU foam to fill up any remaining gaps.

The fridge was taken out and replaced by a system in components from Waeco. It is now 90 litres with an ASU unit inside.

The fridge has 5 cm PU insulation and 10 cm for the base. It reaches -5°C at full power and 6°C at 30% on the thermostat at 21 degrees cabin temperature, so power consumption is quite acceptable. The compressor sits beneath the fridge but the heat generated has no influence due to the thick insulation of the base. The warm air escapes through a vent in front of the sink.

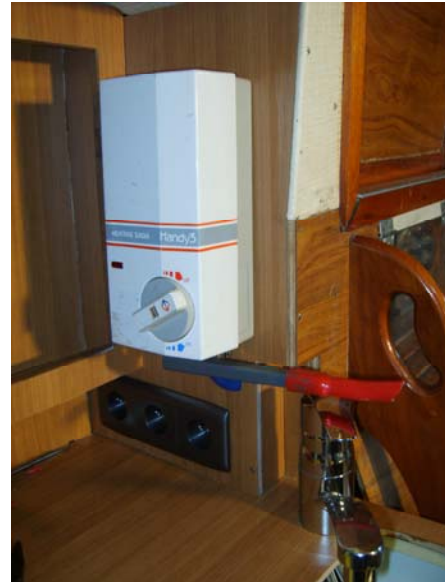
The sink that Marine Projects installed in the M36 was quite shallow and limited in size, so I decided to get a bigger one. The sink tap could have been reconditioned, but space limitations for the tap made me get a new one from Grohe. It works fine with the pressure pump and is supposed to last another 30 years. I installed the sink with a generous amount of Tec-7 so that the inner sides of the marine ply were completely sealed.

Around the sink, I glued PU-foam to reduce the loss of heat from the water when doing the dishes. This also reduces water usage which is a welcome side effect when living aboard for extended periods.

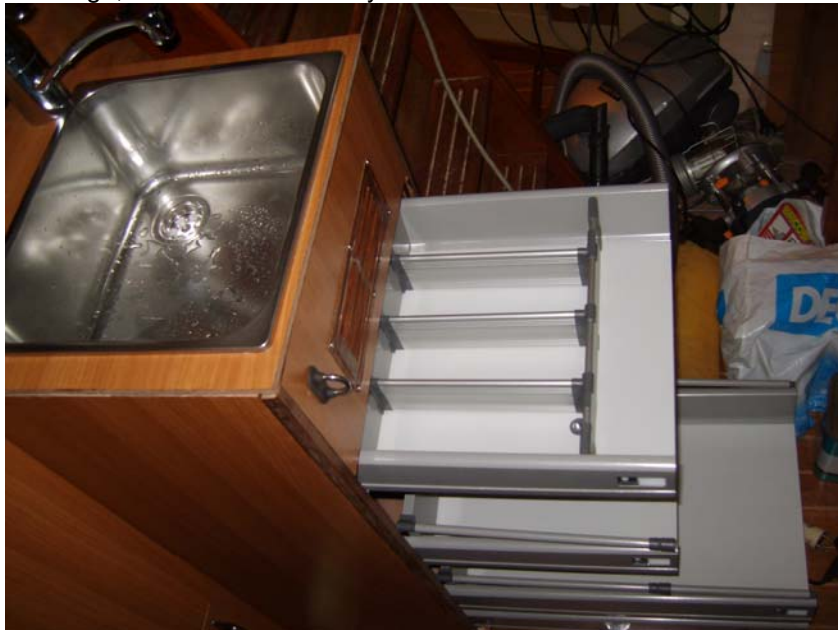
One of the things about the galley I've always considered a drawback was the lack of drawers for pots and pans. They resided in the cupboard beneath the sink and larger items like a wok were stowed beneath the cabin bunks. I tried to get as many drawers into the new galley as I could, which turned out to be four. Everything, including the thermos and the water kettle now has room beneath the sink. Quite amazingly, Ikea was my source for the drawer systems. They have several sizes as well as high and low and I could fit them all quite neatly into the space I had. The fronts were easy to add and adjust and I added cupboard catches to lock them. If any work is required on the systems underneath the fridge, the drawers are easy to take out in future.

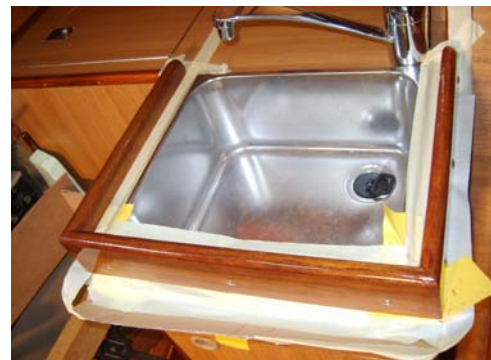
Last but most important for a neat finish, the new worktop had to be bordered with hardwood. The original wood used for this was Meranti or a similar type but I got some Bankirai as this is stronger. To achieve the same colour I experimented with some base varnishes I got from a specialized paint dealer. The small gaps in the corners were filled with wood putty and then varnished and are indistinguishable from the wood.

From the pictures, the new multiplex looks a lot lighter than the old surfaces, but actually has the same appearance. It

is, however, slightly lighter and this makes the galley a more appealing place to work in.

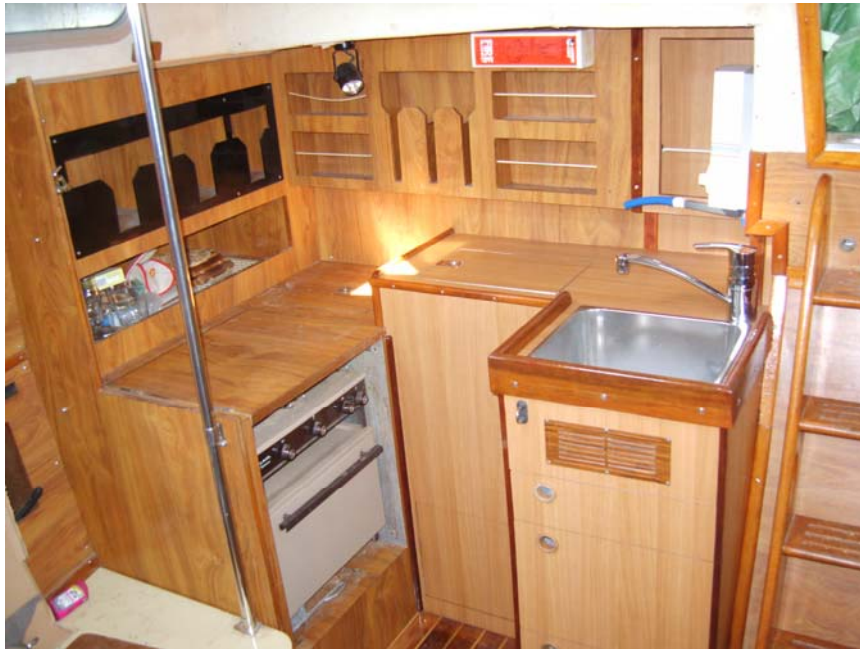
Finished result:

It was more than worth the 1500 Euros and three weeks of work I put in. Only a bit of floor space is lost and a good hand hold for under way is added next to the companionway steps.
